## ITS IMPROVES TRANSITWAY SAFETY

Lowell A. Benson & Roger Huss  
University of Minnesota  
511 Washington Ave. S.E.  
Minneapolis, MN 55455-0375

### **EXECUTIVE SUMMARY**

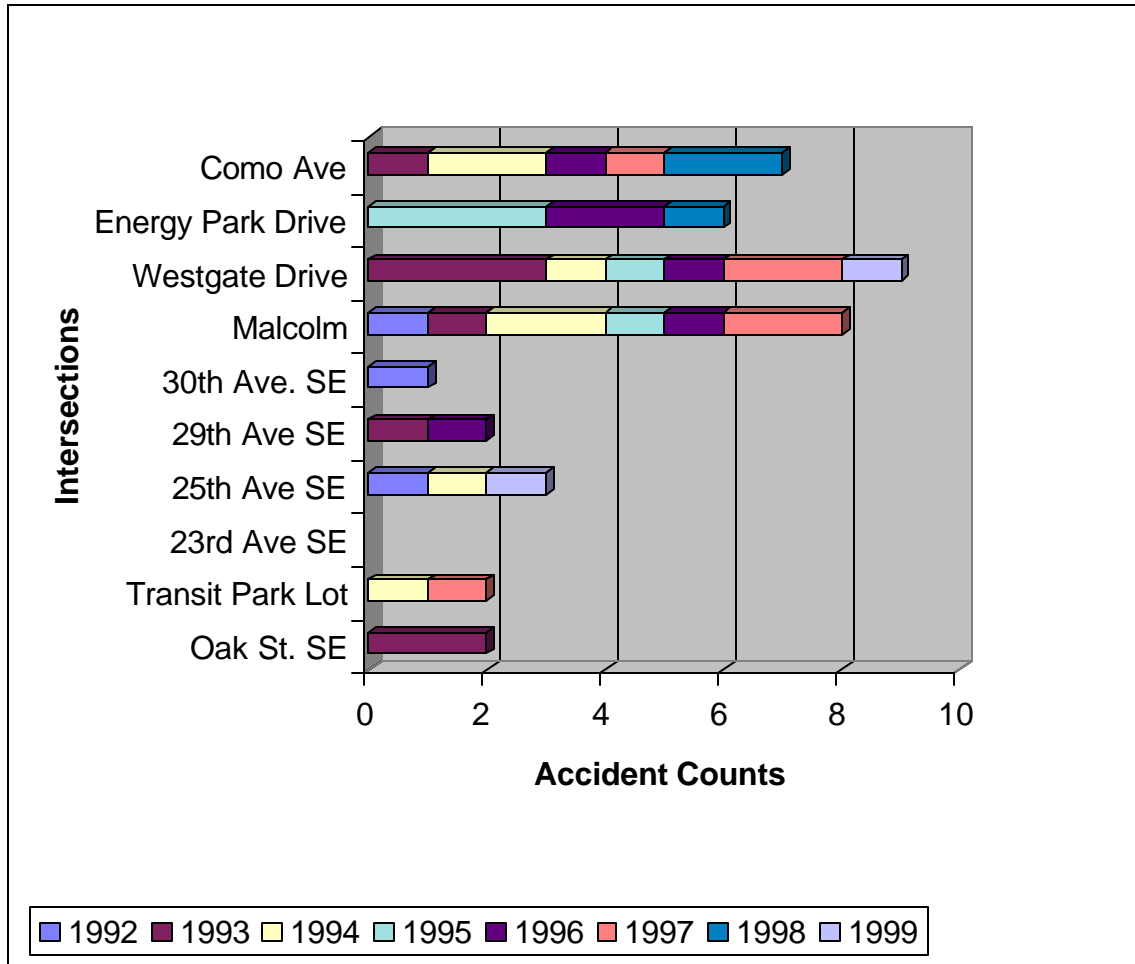
Figure 2. Transitway intersections East to West

and the desire and need to maintain right-of-way on the Transitway, combine to create a high accident rate for the Transitway. Figure 2 shows the intersection accident counts from March '92 to December '99.

Within the first three years of Transitway operation, the University was experiencing two problems on the western half. There were many accidents and non-bus traffic was using the Transitway. A review found that the Transitway intersection accident rate was ~30 times greater than the state average accident rate for two stop sign intersections. The traffic volume on the cross streets is generally higher than the bus volume on the Transitway; buses both directions on weekdays every 5 minutes from 7 to 4:30 plus every 30 minutes until 9 PM. These 356 daily buses serving sixteen stops carried 2,495,732 passengers during the University 1998-99 fiscal year. Most of the cross street traffic is repeat traffic, crossing the Transitway to access an isolated industrial area north of the Transitway. The highest traffic volume of 900 vehicles per day (VPD) exists on both Westgate Drive and Malcolm Avenue. This is four times higher than the ~400 VPD on the Transitway. This traffic volume differential, the relatively low traffic volumes,

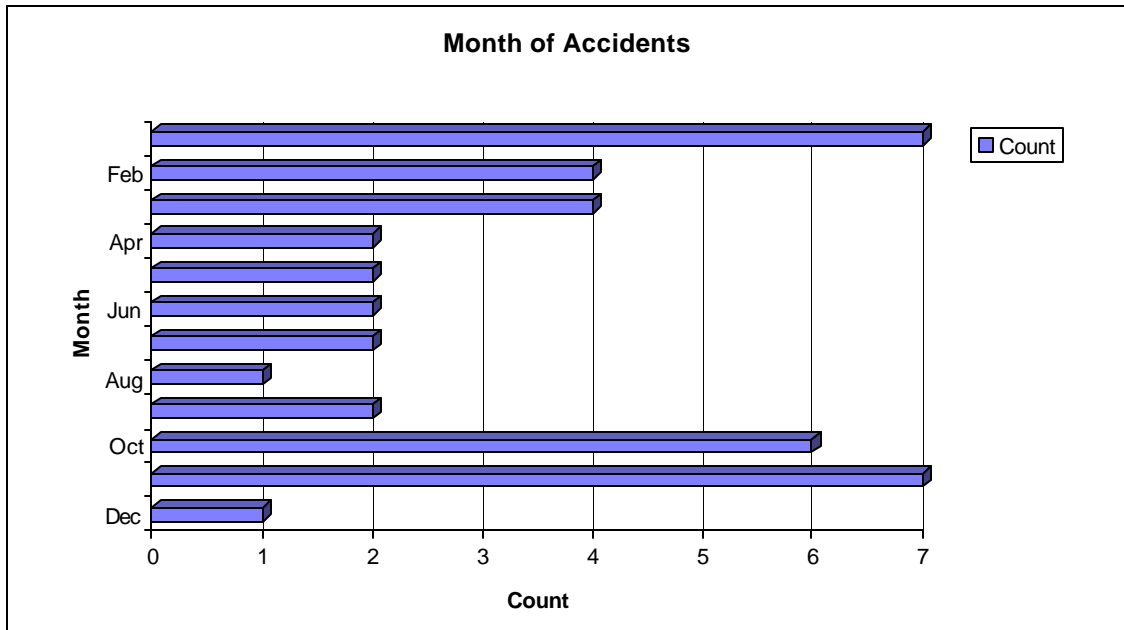
Figure 3. Accident distribution by month

There was no single cause identified for most of the accidents either from the accident data or from the observations. Driver inattention or driver risk taking is a reasonable conclusion. We also know that winter weather brings slippery roads and reduced visibility conditions. Figure 3 showing most accidents during five of the six winter months (October through March) supports this conclusion excluding December because of the reduced bus schedules during winter quarter break.

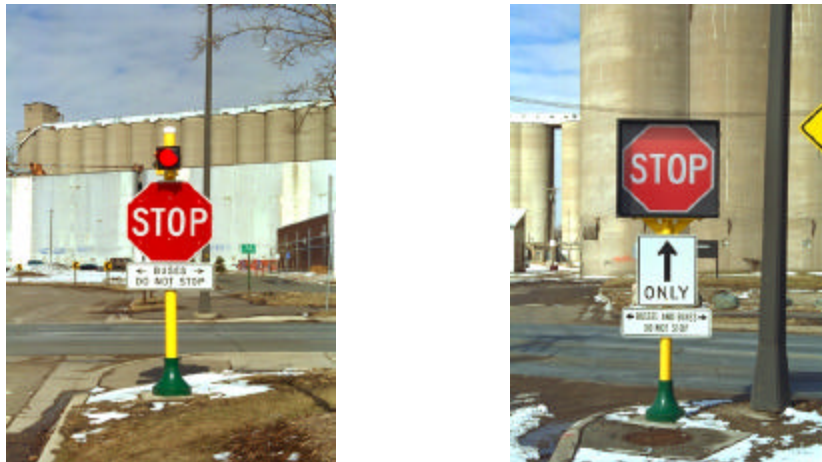
Figure 4. Loop detector activated warning & stop signs

The Fiber Optic STOP Sign is basically a 36" x 36" (915 mm x 915 mm) STOP sign with the white border and letters outlined with fiber optic lights. This sign is lit when buses approaching the intersection pass over the detector loops in the Transitway from either direction. It is also lit when bicycles go over loop detectors in the bicycle path.

The detector loop placement was based on providing 10 seconds of warning for buses approaching at 30 MPH (50 km/h) and bicycles approaching at 15 MPH (15 km/h). This same placement would provide 7 seconds of warning for a bus approaching at 40 MPH (60 km/h) and a bike approaching at 20 MPH (35 km/h). This timing design was also planned for machine vision implementation [Autoscope™] even though bicycle detection is not part of the standard 2004 product. The original design layout had a '170' controller for the warning sign timing control. As a cost avoidance, the management team decided to use direct outputs from the Autoscope™ to turn warning sign light-control-relays on and off.

The five different improvements were installed during the fall/winter of 1997. Based on the design, initial timings for display of the loop detector activated warning devices was set at 11 seconds. After

review, observation, and input from bus drivers, transit officials, and University PTS staff, the warning timing was increased to 17 seconds. Operationally, this timing will provide 15 seconds of warning for a bus approaching at 20 MPH (35 km/h) and a bike approaching at 10 MPH (15 km/h) with an additional 2 seconds of lighted time for the bicycle or bus to clear the intersection.

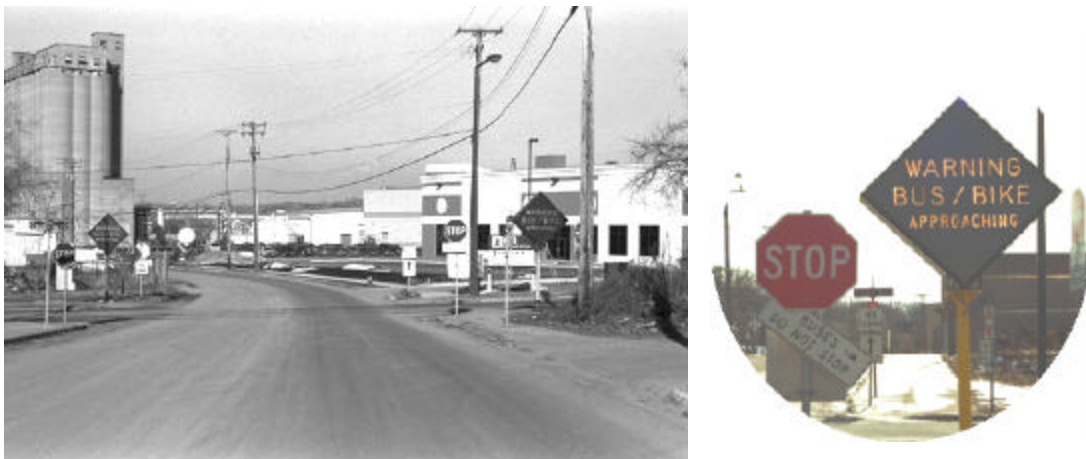
Figure 5. Installation at Malcolm/30th - Autoscope™ activated

The Blank-out Warning Signs contain the message BUSES/BIKES DO NOT STOP. This message is illuminated when activated by the video detection on the transit way and bicycle path. These signs are 48" x 48" (1220 mm x 1220 mm) as shown in Figure 5.

Initially the same 11-second fixed timing was set for the warning devices activated by the Autoscope™. The team requested that Image Sensing Systems, Inc. tailor this Transitway Autoscope™ application to use approaching bus speed detection to determine the duration of the warning device activation. A warning time of 12 seconds is provided for buses approaching at greater than 30 MPH, 14 seconds for 20 to 30 MPH, and 17 seconds for speeds less than 20 MPH. The speed detection was not used for the bicycle approaches (bicycle speed measurement is not a part of the Autoscope™ product.) The warning time for them, as with the loop detectors, was set for 17 seconds. This sign is illustrated in figure 5.

The sign design incorporated a feature to allow bus drivers to be able to tell if the warning signs are activated. This provided a plexi-glass covered hole in the side of the signs facing the approaching bus driver and at right angles to the crossing drivers.

The plexi-glass 'windows' on the side of the signs were originally considered to assist in system maintenance, by confirming that the system is operational. This design didn't work because the internal illumination was insufficient for drivers to observe when driving at or near the Transitway speed limit. A larger light source, similar to confirmation lights for emergency vehicle preemption systems was incorporated in mid-1998, fixing the insufficient illumination problem.

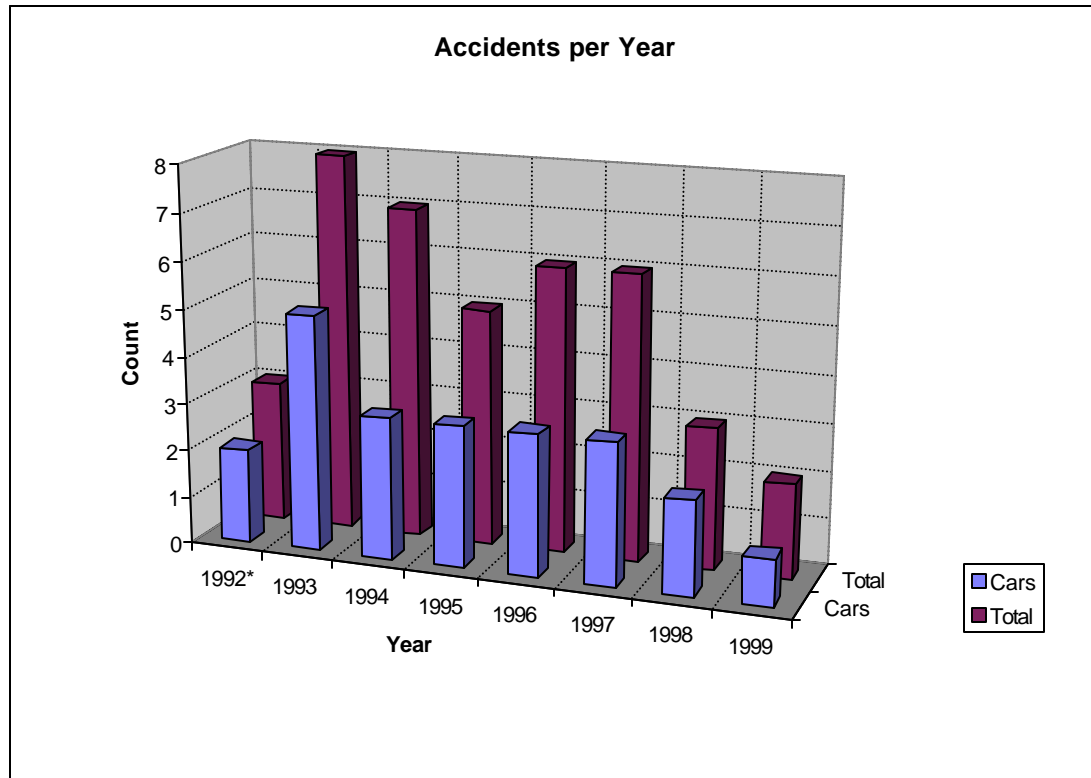
Figure 6. Count as of 12/31/99

The last bus => truck accident in the test bed area was in March 1999 when a snowplow and bus sideswiped each other between intersections. The last bus => car accident in the test bed area was May 1999 (figure 6.) when a car ran a stop sign in front of a bus. The most unusual accident (of any type) along the transitway was October 1997 when a pedestrian (on roller blades) clipped a bus near the Oak Street entrance to the Transitway. One accident in two years at the seven-intersection test bed [0.5 per year] is significantly better than the 23 over six years [4 per year] before the devices were activate.
